TSB-248 Flywheel Resurfacing

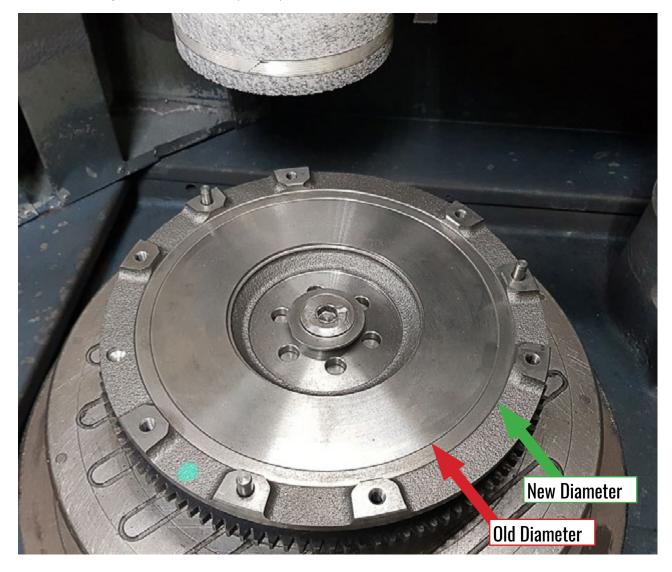
The clutch kit supplied for this vehicle is slightly larger than the original unit. It is therefore mandatory that the flywheel friction surface gets resurfaced to the outer edge of the step as illustrated in the image below. The flywheel step needs to be 7.5mm (0.295").

Failure to do so will affect the performance and life of the clutch.
