Part number SES1500TT
2017-18 Honda Civic
Sport
1.5L turbo 4cyl.

Complete kit:

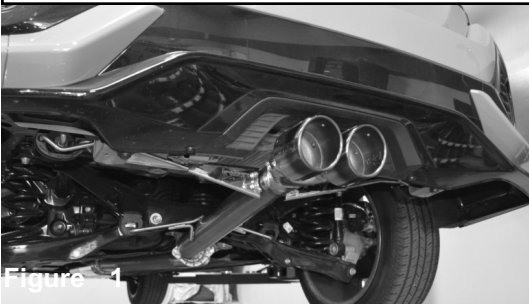
- 1- 3 piece cat back dual exhaust**
- 1- triangle gasket (#12036)**
- 2- 3.00 gasket (#17060)**
- 4- M10 hex bolt (#6038)**
- 4- M10 hex nut (#6069)**
- 4- M8 Socket cap screw (#6076)**

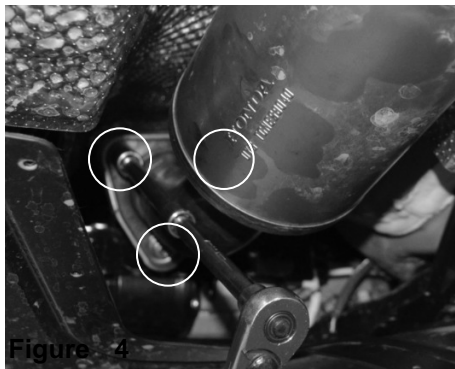
Figure 4

Loosen the 3 nuts holding in the pipe using 14 mm socket with wrench. Save these 3 nuts for later install.

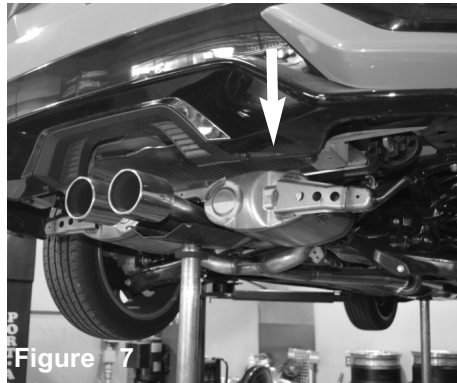
Figure 7

Carefully position and slide back and remove the exhaust out of the vehicle.

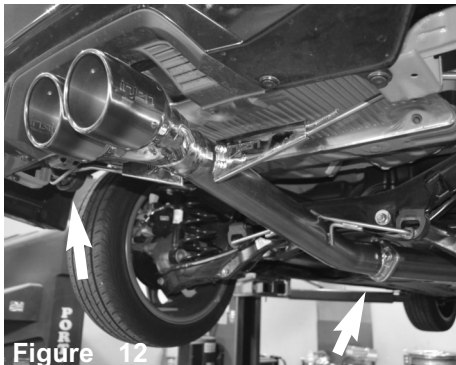
Figure 12

Position all the hangars to to the isolation mounts. **(look for UP sign on mount)** Position and adjust fitment. *Do not tighten.*

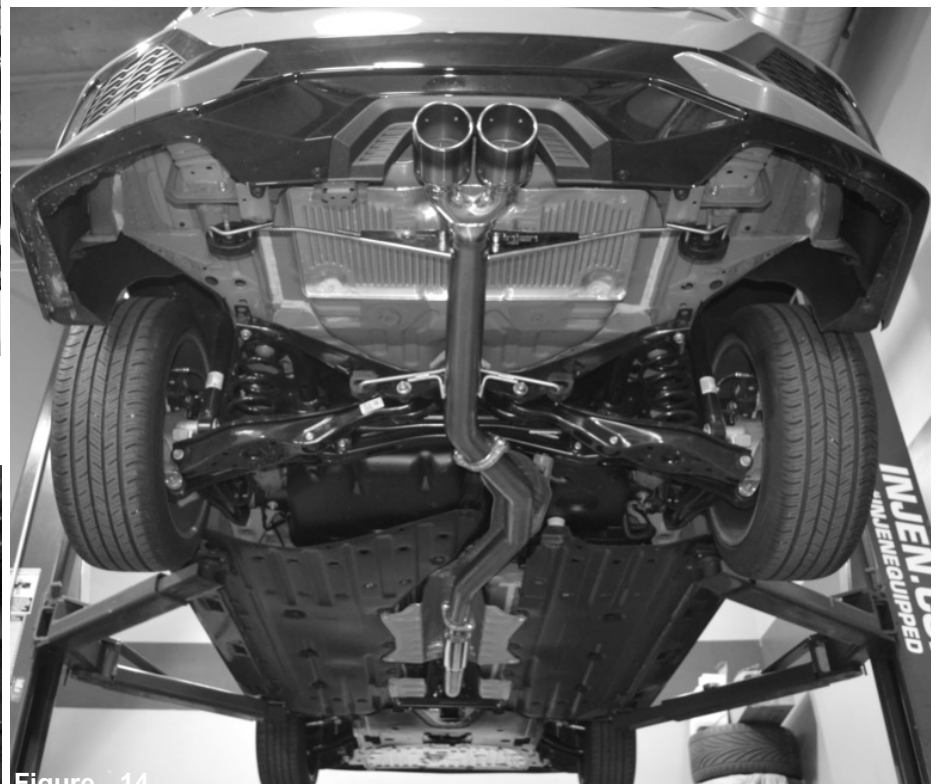
Figure 14

Congratulations! You have just completed the installation of this exhaust system. Verify and adjust the rear section of the exhaust, make sure muffler and tip do not touch any plastics or it can melt. Periodically, check the alignment of the exhaust, normal wear and tear can cause nuts and bolts to come loose. **Note: Check clearance and adjust if needed! Failure to check the alignment and adjust the exhaust can cause damage that will void the warranty. Injen Technology is not responsible for any damages caused by/from improper installation.**
